# **ENVIRONMENTAL SURVEY AND ASSESSMENT OF GATEWAY ARMY AMMUNITION PLANT**

**FINAL REPORT**  
**June 1982**

4. TITLE (and Subtitle) Environmental Survey and Assessment of Gateway Army Ammunition Plant		5. TYPE OF REPORT & PERIOD COVERED Final Report December 1981 - June 1982

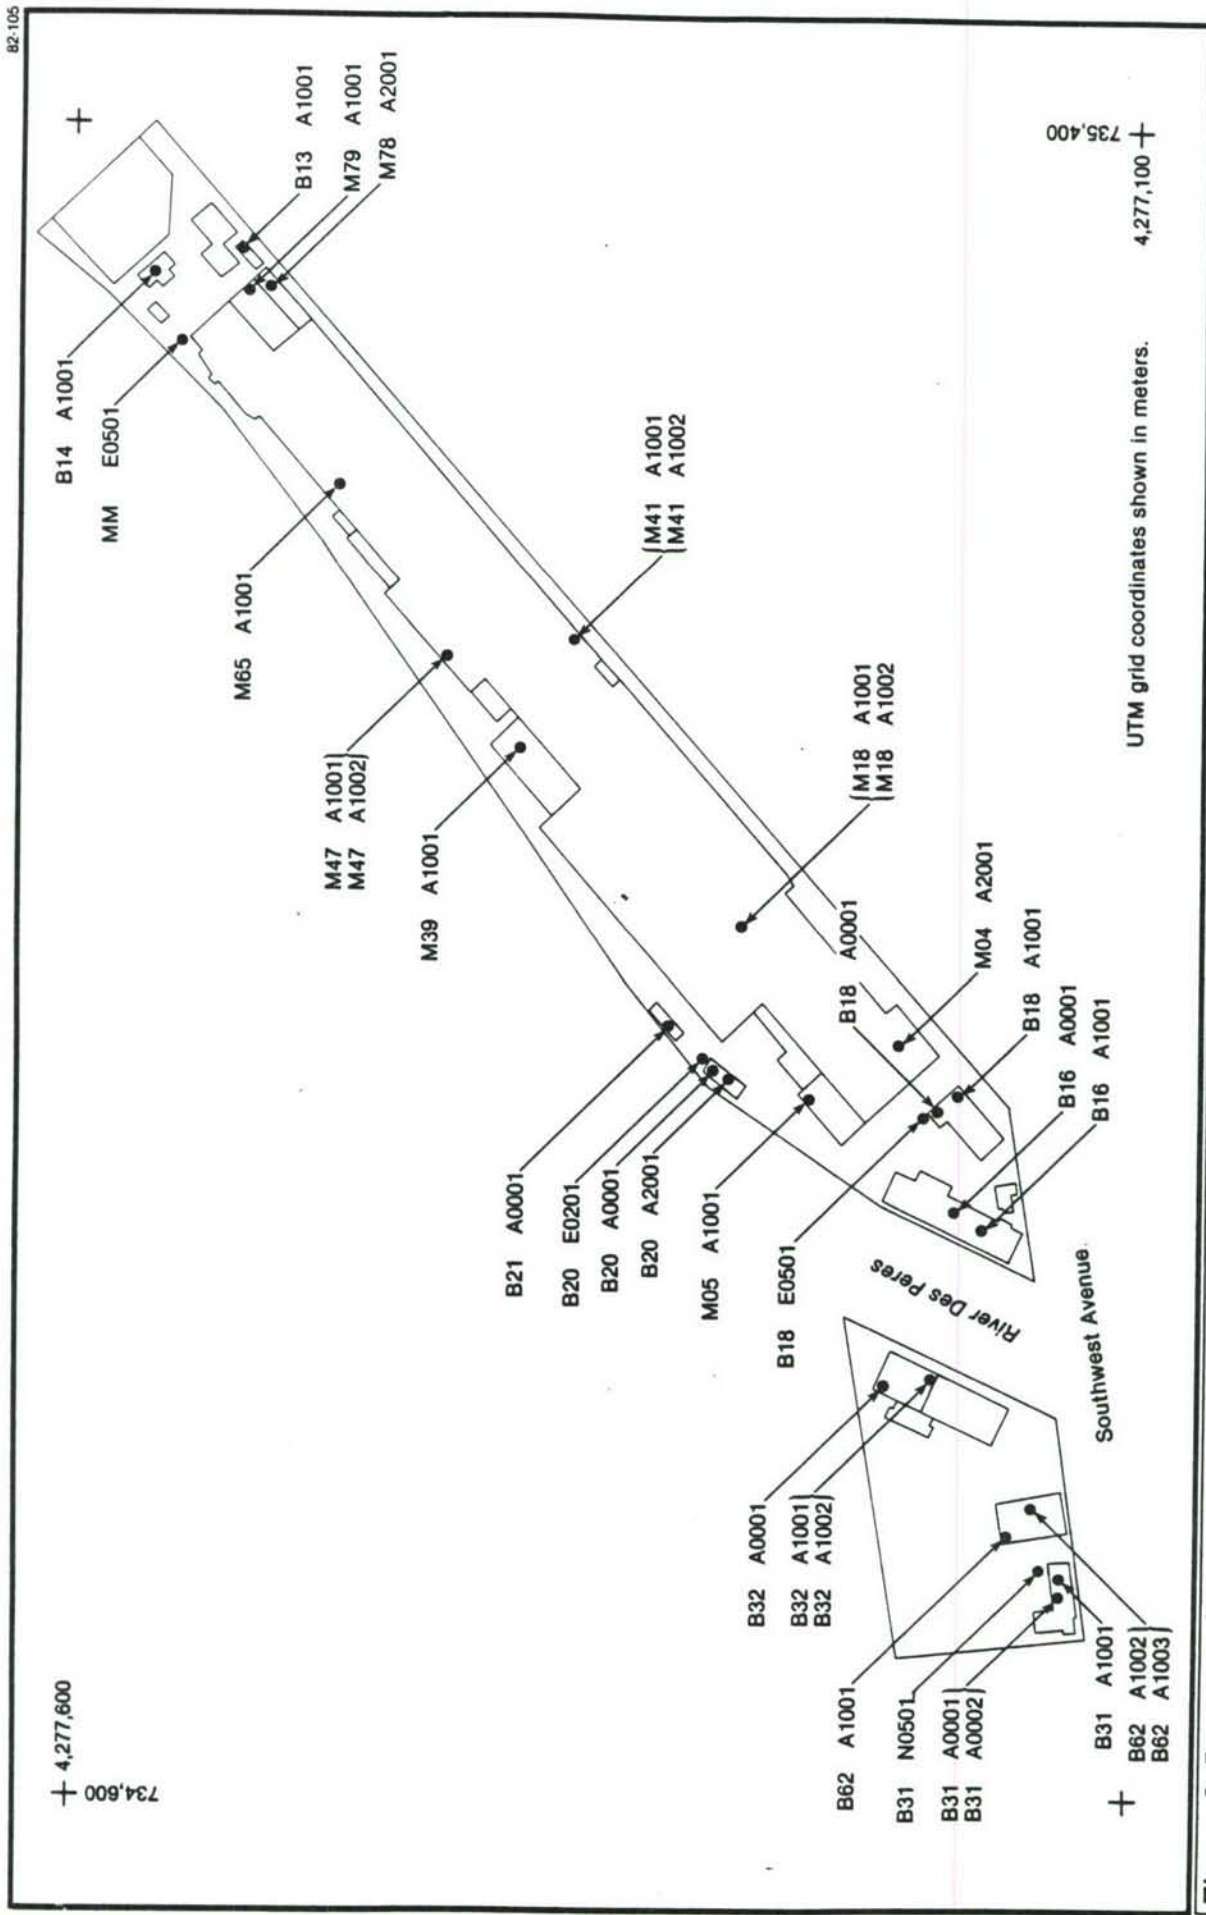
Figure 3-5  
AIR SAMPLING LOCATIONS

sampling. Table 3-10 presents the results of analysis of the air samples at each site. The locations of the sampling sites are shown in Figure 3-5.
